CONTRACT REPORT EL-92-2

STABILIZATION OF DAKOTA SANDSTONE SURFACE OF THE FARIS CAVE PETROGLYPHS KANOPOLIS LAKE PROJECT, KANSAS

David A. Grisafe

August 1992 Final Report

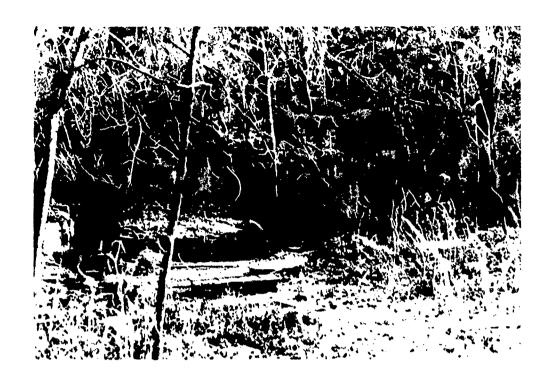
Figure 2. Approach to Faris Cave Site, showing the three doorways to the late-19th century manmade caves or rooms at the base of the cliff. The northernmost room (extreme left) still contains an active spring

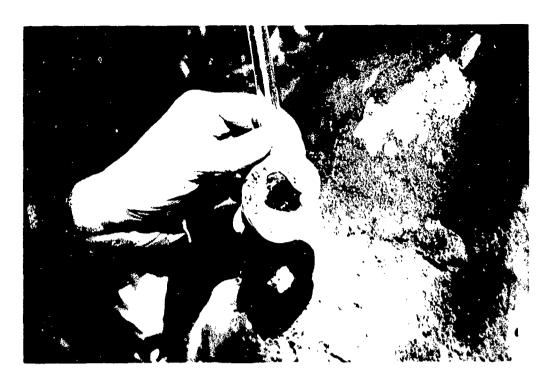
- absorbed. Some difficulty was experienced in obtaining a good seal because of the very friable nature of the stone and biological growth at some locations (Figures 8 and 9).

Figure 8. Biological growth often made it impossible to form a watertight seal (note residue on ring of mastic) between the base of the capillary tube and the sandstone

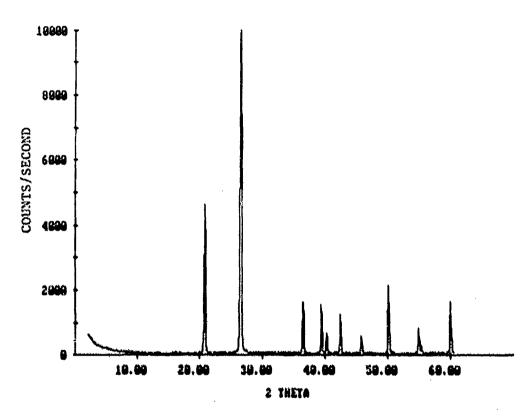
- 29. A summary of the chemical analyses for seven samples is shown in Table 2. In general, the stone consists of over 96 percent silica and about 1.5 percent iron oxide. The remainder is divided between the loss on ignition at 1,000 °C and several oxides. The low alumina content indicates the absence of any significant amounts of clay or feldspar minerals. This is in agreement with optical microscopy. Optically, one observes quartz grains, many with a thin, fine-grained buff coating, and occasional grains of opaque mineral(s) and muscovite mica. Based on these observations, this sandstone would be classified as an arenite or arenaceous sandstone. The x-ray diffraction patterns showed only the presence of quartz (Figure 10). Since the iron oxide content is low and iron minerals and iron-bearing clay minerals are often poorly crystallized, the absence of any iron minerals in the diffraction patterns is not surprising. The color under the microscope suggested that some of the iron may be present in traces of clay or as limonite. A piece of sandstone higher on the cliff face that possessed a higher iron content did show traces of goethite in the x-ray diffraction pattern.

Figure 10. X-ray diffraction pattern (2 theta versus counts per second) for a sample of the Dakota Formation sandstone at the Faris Cave Site. All seven samples collected at the site yielded the same pattern with all diffraction peaks due to quartz

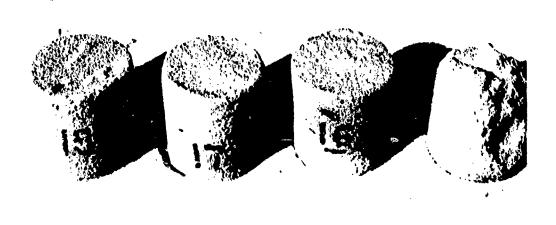
- 32. As mentioned earlier, three cores from each treated set and three untreated cores were evaluated for their freeze-thaw resistance by submitting them to 16 hr at -20 °C followed by 8 hr immersion in water. Except for complete failures, cores were submitted to a total of 100 cycles, and the weight loss was measured after every 25 cycles.

- 33. Table 6 shows the percent weight loss for each set of cores after 25, 50, 75, and 100 cycles. The data show an increased resistance to freeze-thaw cycling (lower weight loss) with increasing numbers of treatments. Two of the untreated cores failed completely (disintegrated completely to sand grains) during the first 25 cycles, while the third core in the set failed completely on the 33rd cycle. By contrast, none of the treated cores failed completely during the 100 cycles, including those given only a single 2-min capillary absorption treatment (Figure 11). However, the latter cores were friable, suggesting that more than one consolidation treatment is necessary for this type of stone.

Figure 11. Results after 25 freeze-thaw cycles. The three cores on the left had received one 2-min capillary absorption treatment with Conservare OH stone strengthener. These cores show no damage. By contrast, the core on the right is all that remains from a set of three untreated cores. The other two cores completely disintegrated
